LIGHTNING EFFECTS RELATING TO AIRCRAFT
PART I - LIGHTNING EFFECTS ON AND ELECTROMAGNETIC
SHIELDING PROPERTIES OF BORON AND GRAPHITE
REINFORCED COMPOSITE MATERIALS

F.A. Fisher
High Voltage Laboratory
General Electric Company

Technical Report AFAL-TR-72-5

January 1972

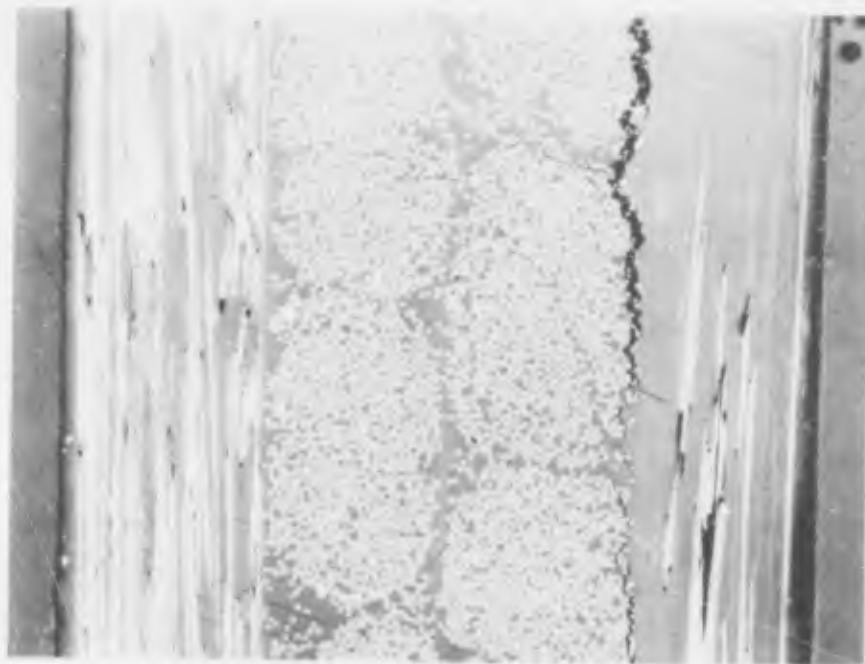
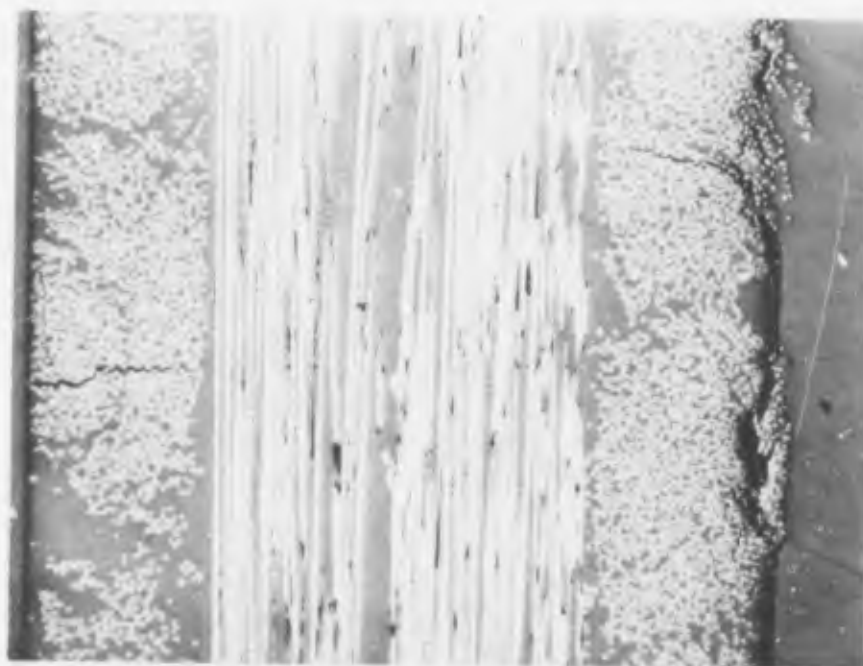
FIGURE 84 - 100X Photomicrograph of a Damaged Area of Graphite Fiber/
Epoxy Panel After Exposure to Simulated Lightning Discharge

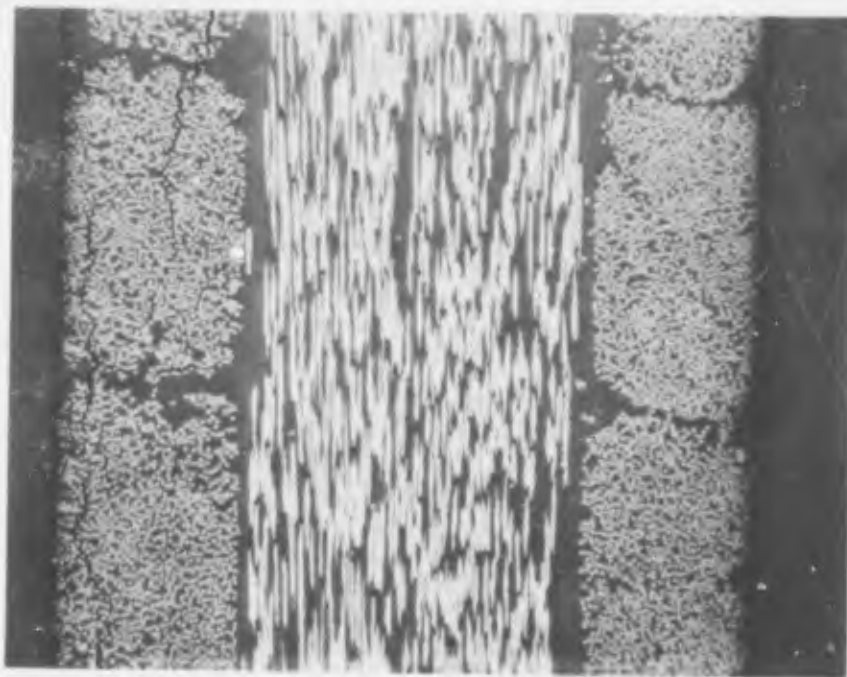
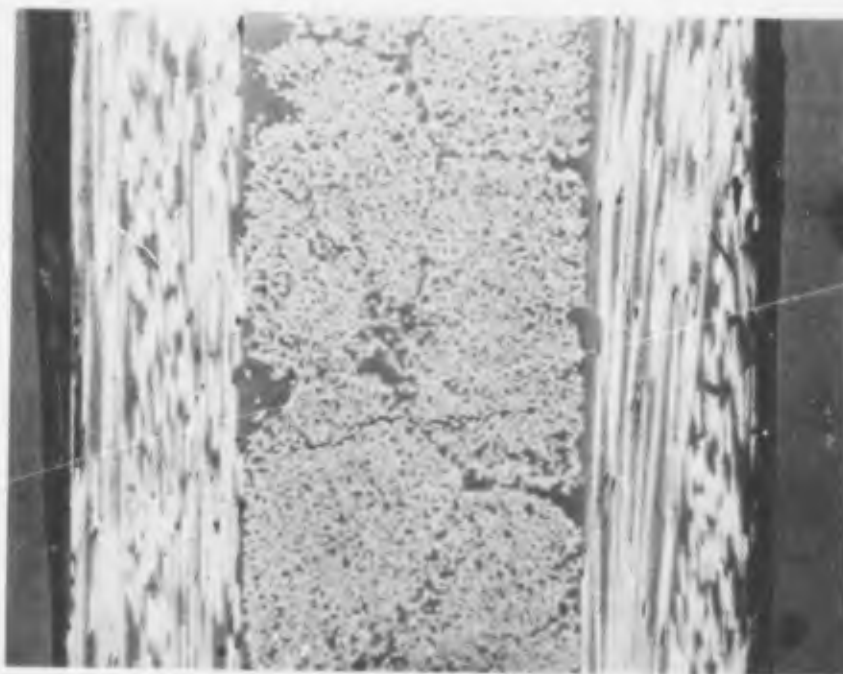
FIGURE 85 - 100X Photomicrograph of a Damaged Area of Graphite Fiber/Epoxy Panel After Exposure to Simulated Lightning Discharge

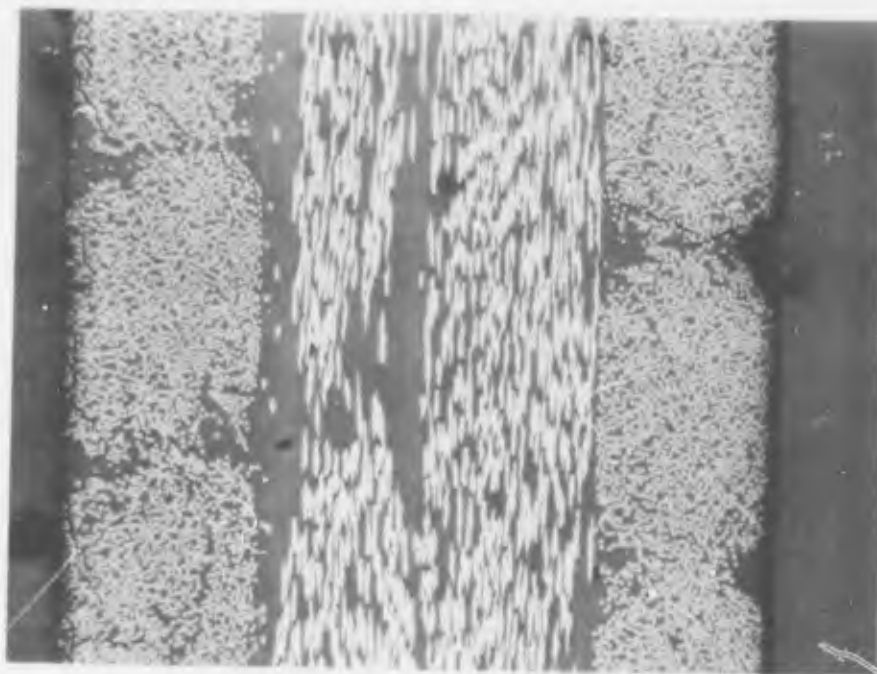
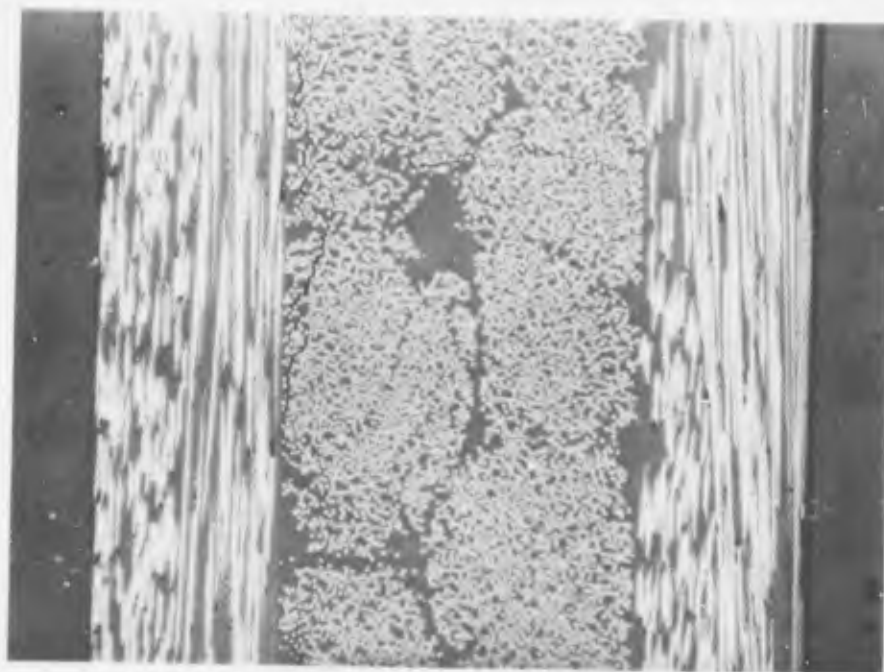
FIGURE 86 - 100X Photomicrograph of a Damaged Area of Graphite Fiber/
Epoxy Panel After Exposure to Simulated Lightning Discharge

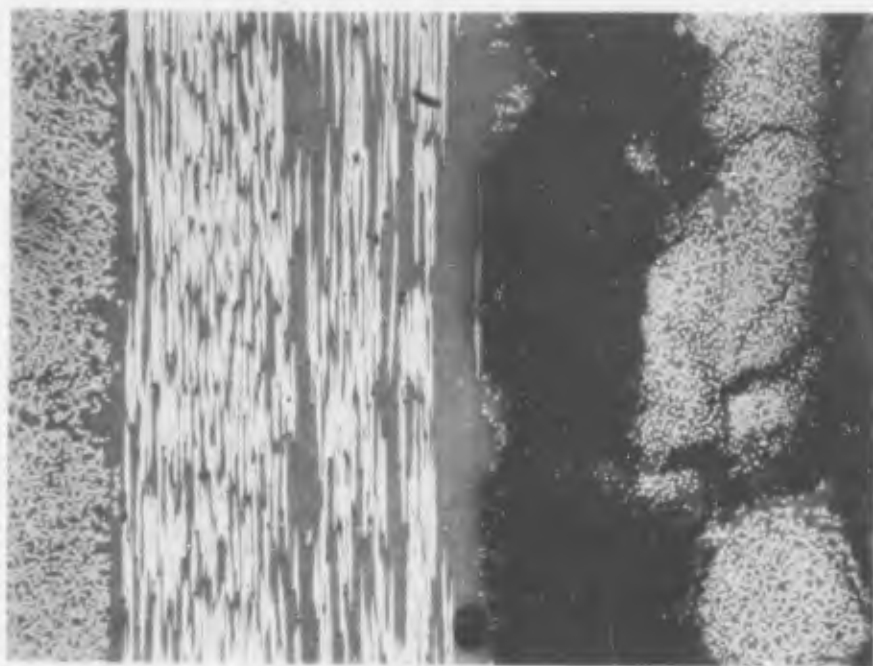
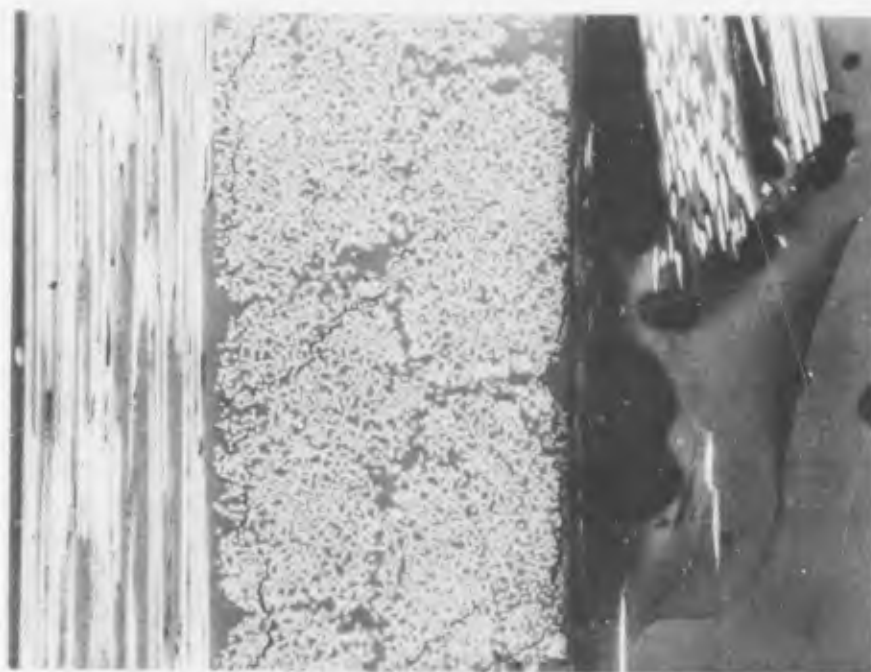
On panel LS-70-4, tested at 184 kA, it is interesting that the tensile strengths of specimens 1 and 2 are normal while specimen 3 is significantly stronger in spite of the massive damage to the top ply shown on Figure 87. Specimen 3 was, of course, immediately below the stroke-attachment point. Again, the fibers and resin on the two inner plies of this specimen do not look any different than do the fibers and resin on specimens further from the stroke-attachment point or on panel LS-70-3 which was tested at a 57.5 kA level. On photomicrograph 3a of Figure 87 one can see a considerable amount of blacken-

FIGURE 87 - 100X Photomicrograph of a Damaged Area of Graphite Fiber/
Epoxy Panel After Exposure to Simulated Lightning Discharge

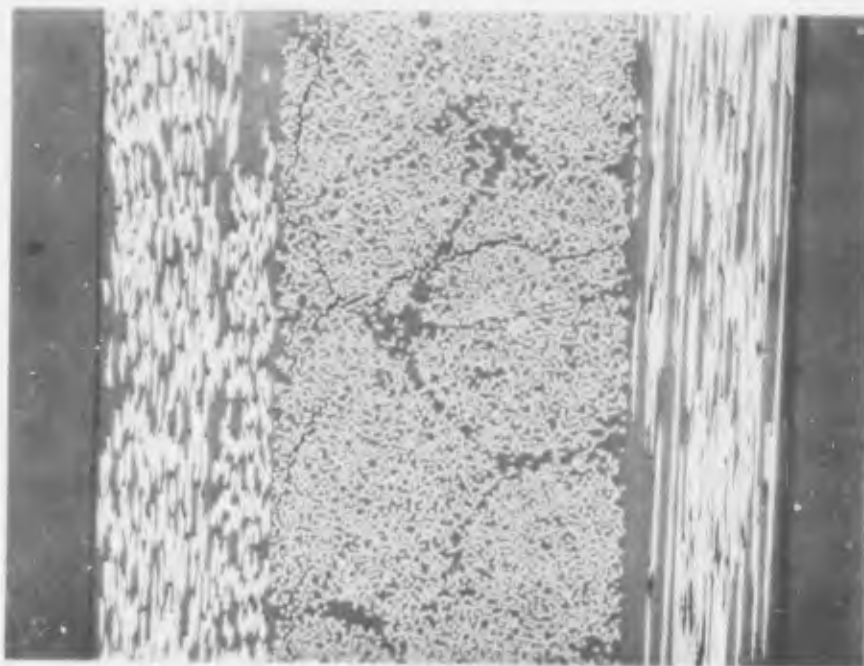
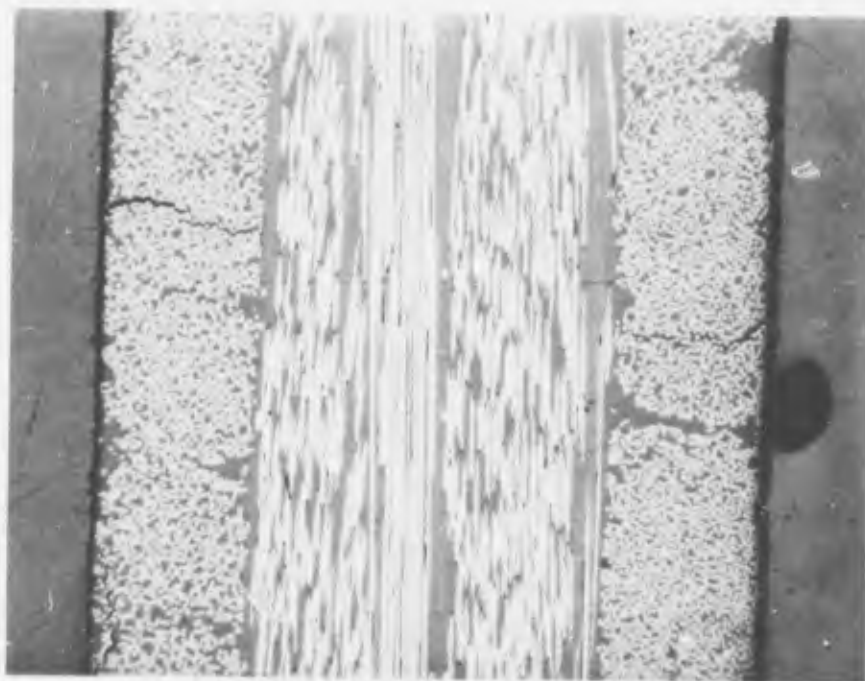
FIGURE 88 - 100X Photomicrograph of a Damaged Area of Graphite Fiber/
Epoxy Panel After Exposure to Simulated Lightning Discharge

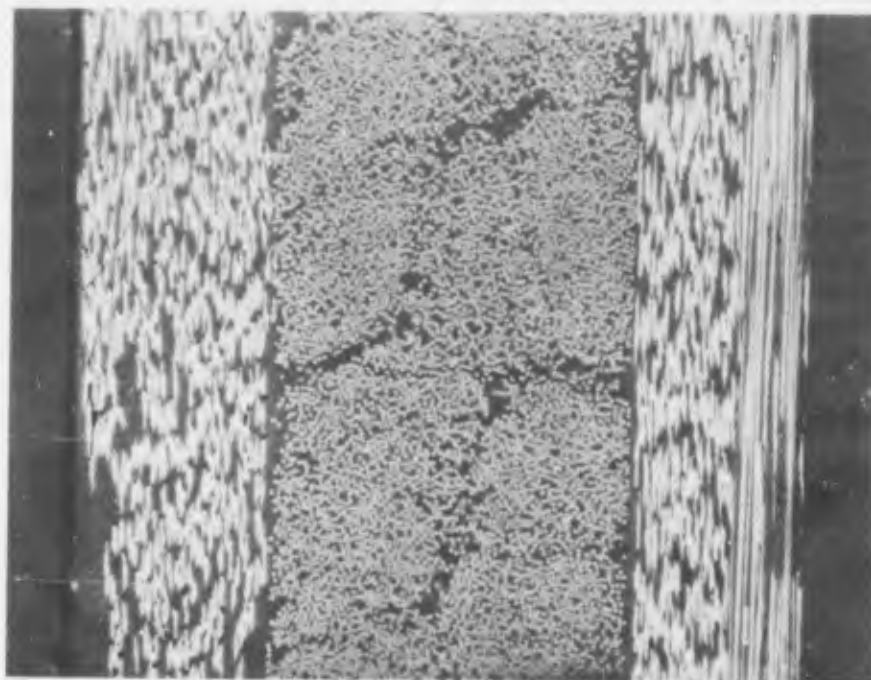
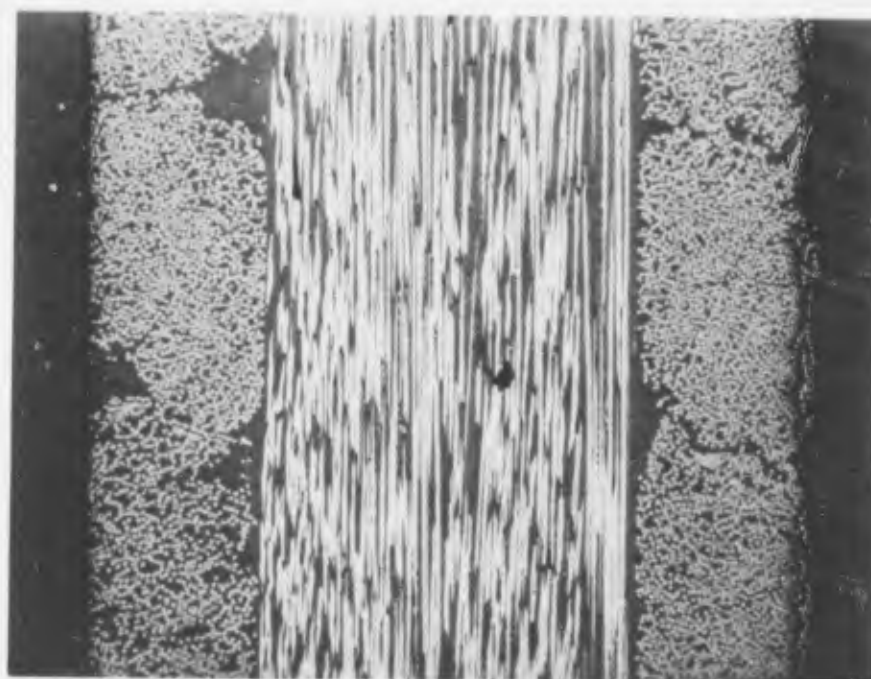
FIGURE 89 - 100X Photomicrograph of a Damaged Area of Graphite Fiber/
Epoxy Panel After Exposure to Simulated Lightning Discharge

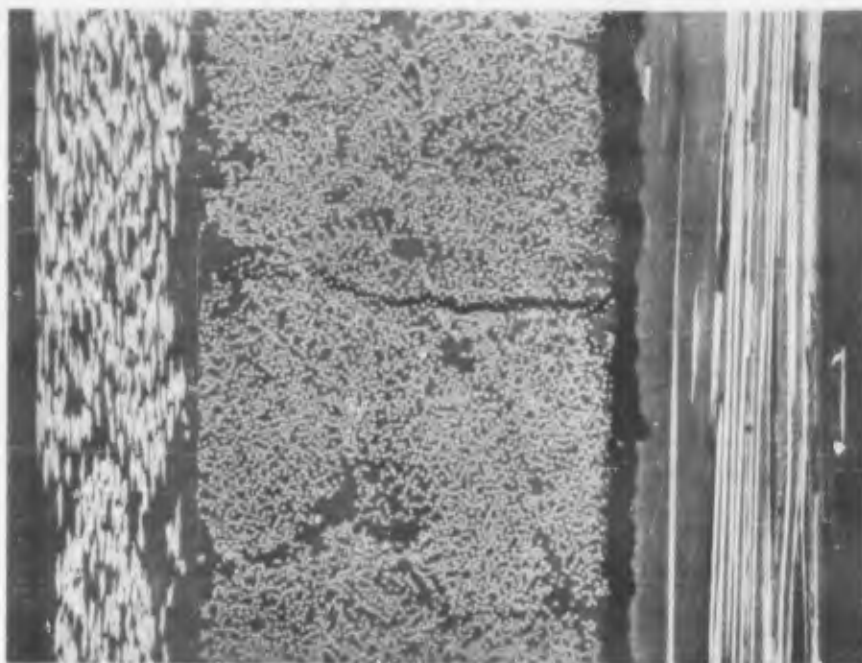
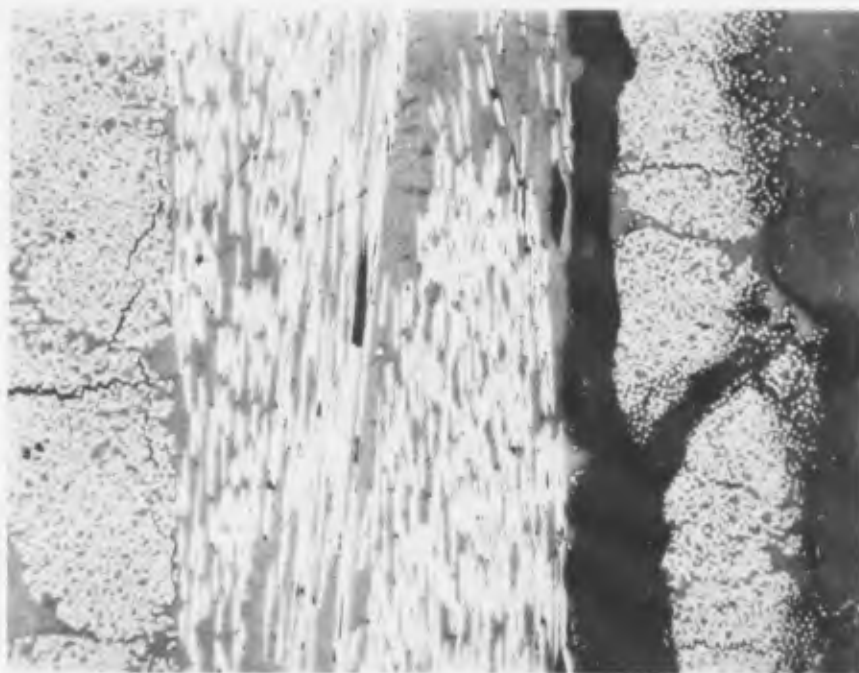
FIGURE 90 - 100X Photomicrograph of a Damaged Area of Graphite Fiber/
Epoxy Panel After Exposure to Simulated Lightning Discharge

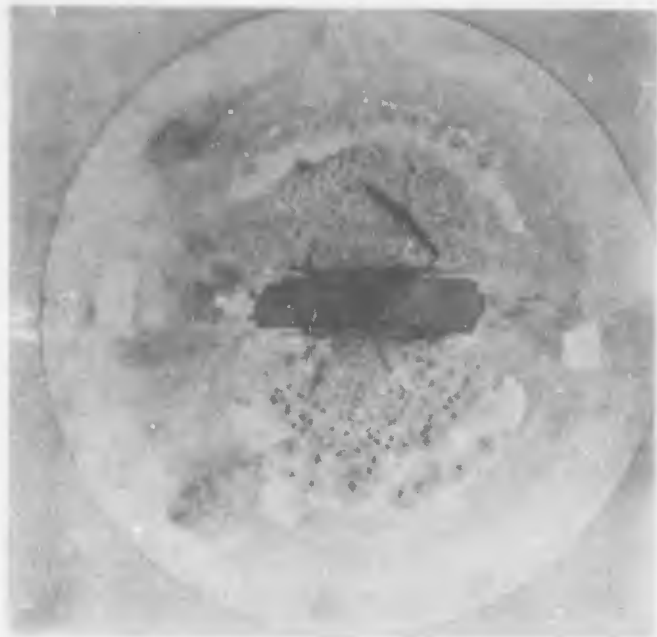
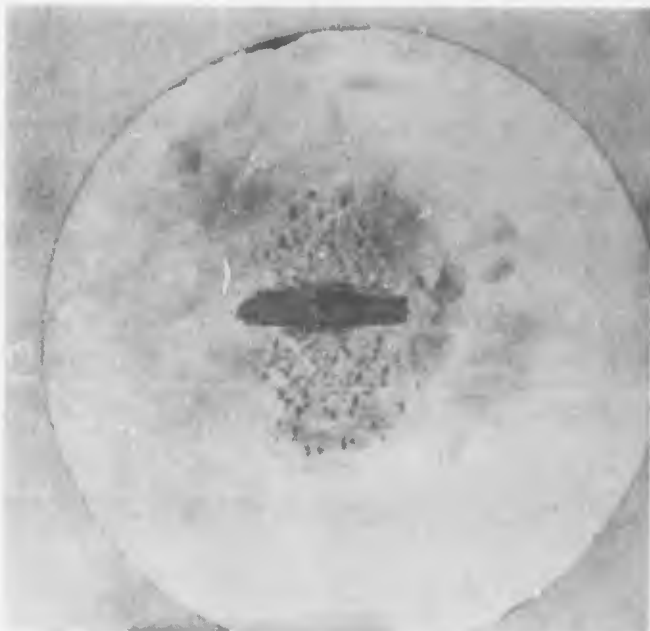
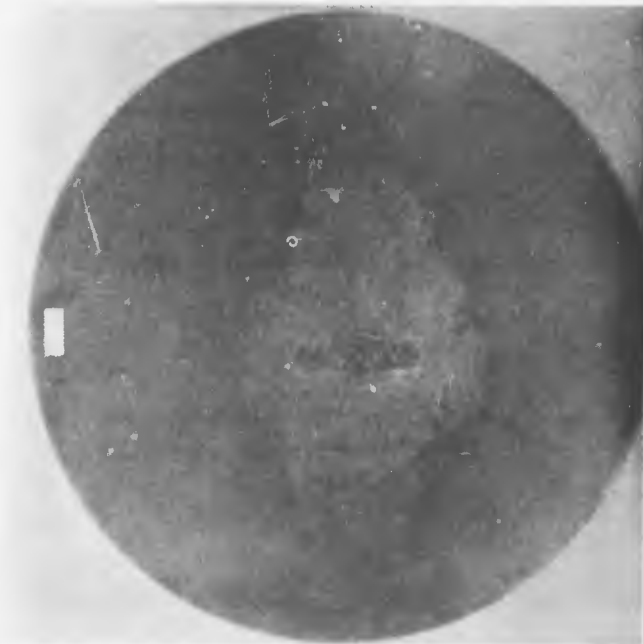
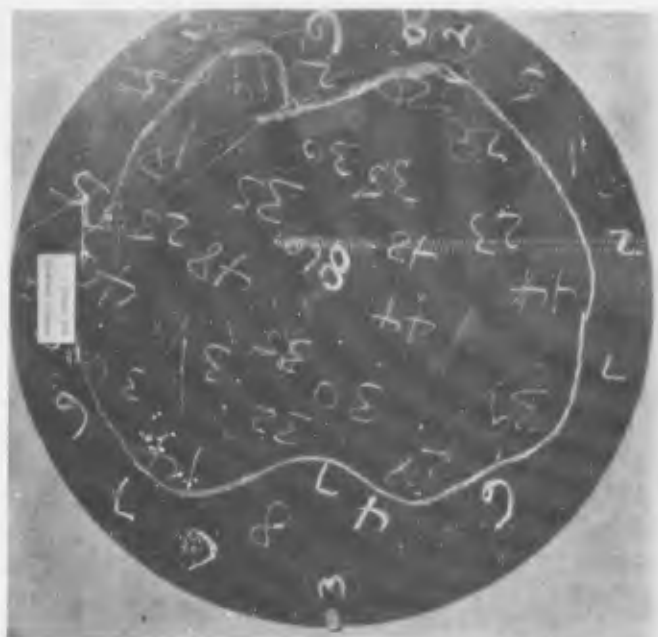
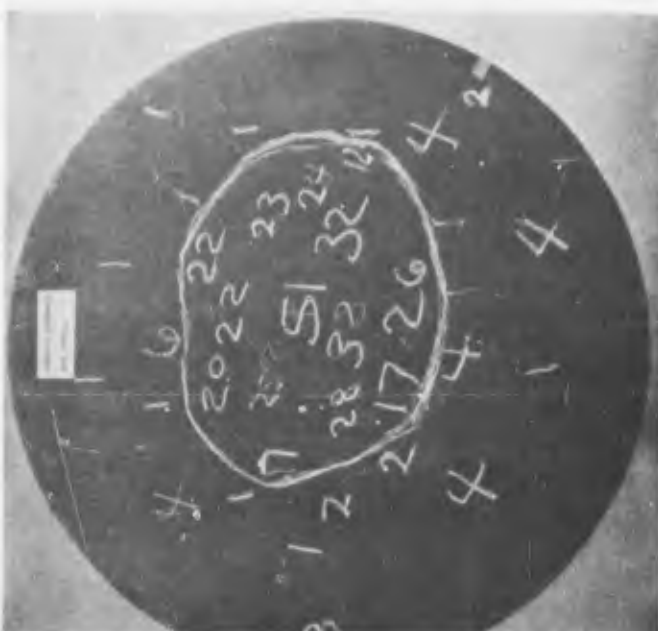
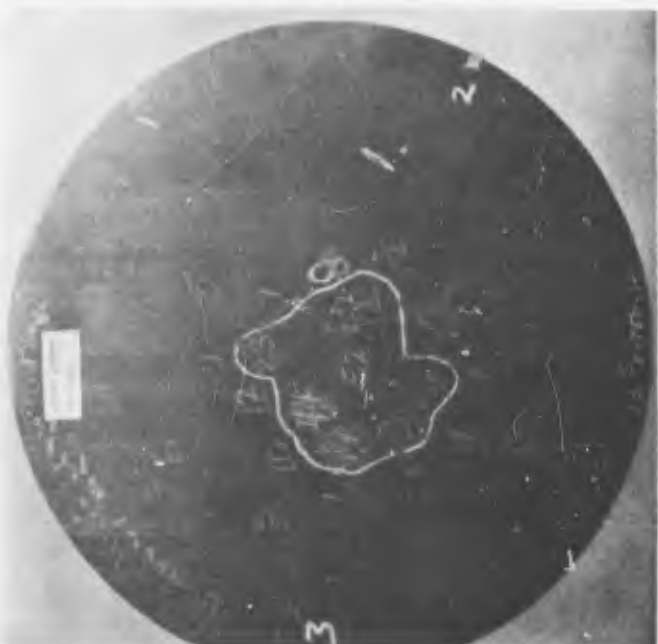
FIGURE 92 - Photographic Reductions of Panels LS-70-12, LS-70-13, and LS-70-14 Showing Both Sides After Strikes of Simulated Lightning

this thick panel as on the thinner 0.040" panels, but the physical lifting or destruction of the first layer of fibers was less on this thick panel. The arc did not blow a hole through this panel as it did on the thinner panels. The back surface was undamaged, at least visually; however, tapping the back surface with a coin showed a dead area in the center. At the outer edges the panel rang clearly as though the fibers were undamaged.

Acoustic impedance measurements were made in many locations of each panel. These are shown on Figures 91 and 92, along with the visual appearance of the panels after a test. For these two figures the photographs of each front surface were reversed so that areas of arc impingement would correspond to acoustic impedance values mapped on back sides of each panel. On the figures high numbers correspond to damaged areas while low numbers correspond to structurally-sound areas. The scales are relative, but the larger the number, the greater the damage. The relative acoustical impedance was written on the panels with chalk. In a few cases, the photographs of the panel have been retouched with white ink to make numbers reproduce better for this report. Those areas where the tests show significant damage are outlined in chalk. Again, as a rough rule of thumb, it appears that the diameter of the damaged area, as determined acoustically, is about twice the diameter of the area on the panel in which fibers were physically lifted or blown away by the resulting arc.

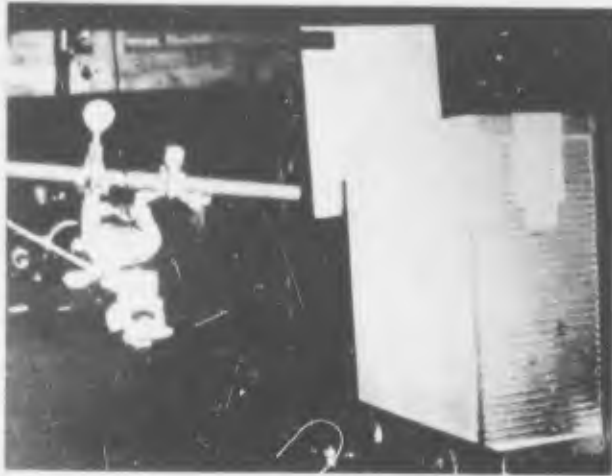
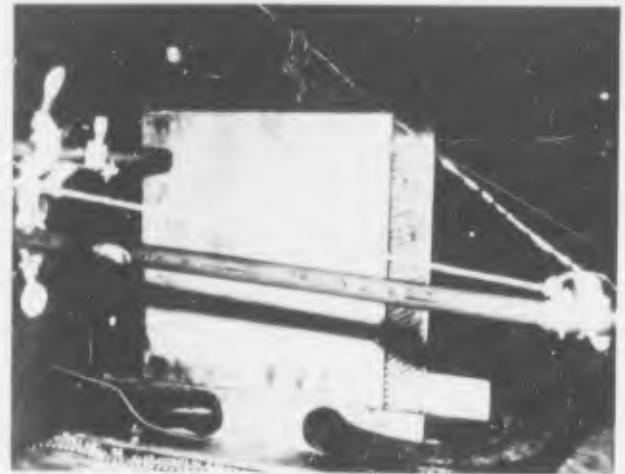
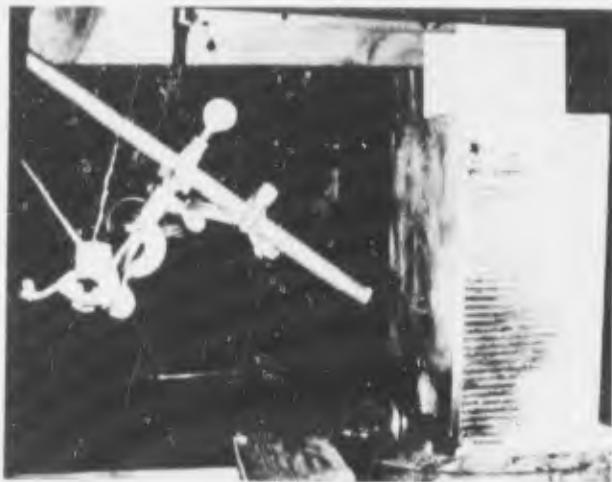
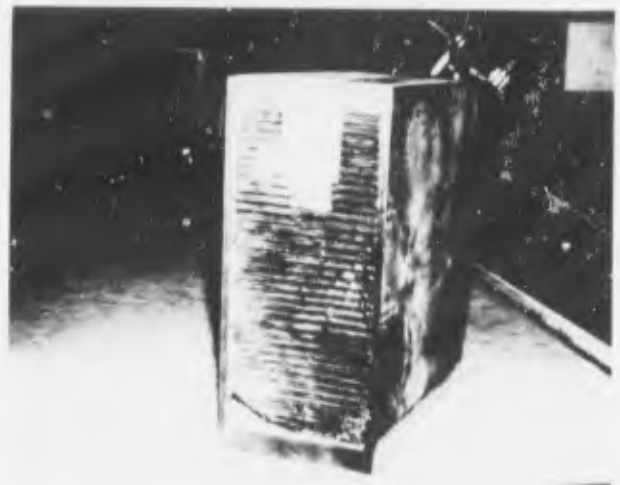
FIGURE 108 - Before and After Photographs - Panel BR-109-3

This was a rectangular honeycomb panel that received four test shots on one side and one on the other. Photos taken before and after the tests are shown on Figure 108. The first shot was at a current level of 4.85 kA peak. This shot did little more than discolor the coating over a 3.5" diameter circle around the contact point. No other visual damage to the honeycomb material was noted. The test did, however, increase the resistance of the silver coating. Before the test, resistance had been measured diagonally across the panel, and between the two sets of edges. The measurements of resistance before and after are given in Table XVIII.

The second shot was to a different point on the panel, but on the same side. At a current level of 72.7 kA, there again was only discoloration of the surface coating, with no damage to the panel itself (Figure 108B).

The third shot, at 111 kA, again resulted in a discoloration over about a 3.5" diameter circle, and produced pitting of the coating at the point of stroke contact. It did not, however, result in any apparent damage to the panel itself (Figure 108C).

The fourth shot was at the level of 168 kA. This shot again gave pitting of the surface at the point of contact. By tapping the panel around the stroke-impingement point, there was found a 0.5" wide dead area. This shot also gave burning of the honeycomb material between the two panel faces (Figure 108D). At the time of test, no attempt was made to determine how deep into the honeycomb the damage extended.

The last test on this panel was made on the other side at a current level of 149 kA. The damage to the coating covered an area of about 2.5" x 2.0". There were approximately 15 pits in the surface of the panel, the largest pit being 0.75" x 0.375". Tapping of the panel with a coin did not reveal any dead areas like those found at the 168 kA level on the other face of the panel. The test did cause considerable blackening of the honeycomb material. None of the tests, however, seemed to cause any major structural damage to the panels.

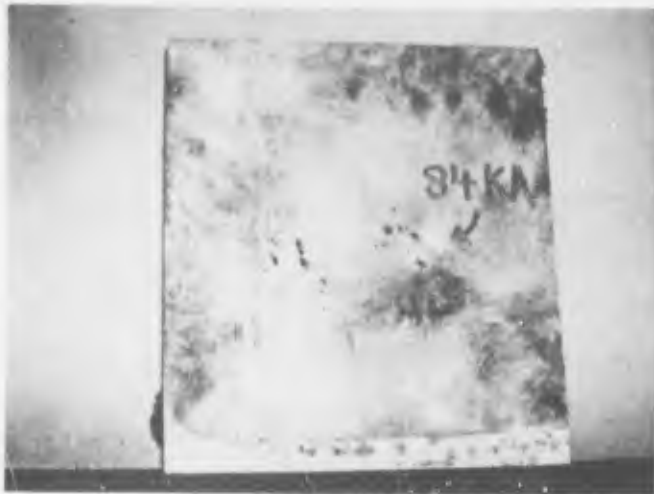
A. Sample BR-109-1 Side 2 After 84 kA and 111 kA Discharges

The second side also received two shots. The first, at a current level of 84 kA, caused pitting of the surface about 0.25" diameter. There were a number of smaller pits also, these pits forming a cluster about 3" in diameter.

The last shot on the panel was on side two at 111 kA. Again, this caused numerous small pits over a region approximately 2" in diameter. It also caused three pits of dimensions approximately .25" x .25".

Figure 109-A shows the damage on the second side of this panel.

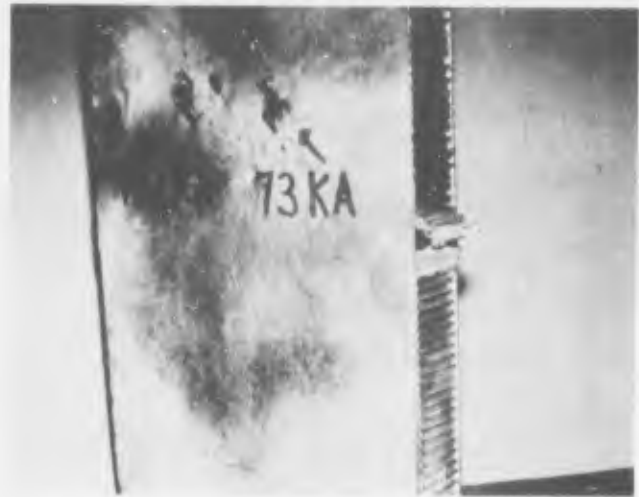
B. Sample BR-103-3 Side 2 After 73 kA and 107 kA Discharges

The second shot was at a level of 72.7 kA. It blew a 1" x 0.5" hole in the panel and blew a piece of honeycomb (1" square) loose from the edge of the panel at the point nearest to the arc. A photograph of the resultant damage is shown on Figure 109-B.

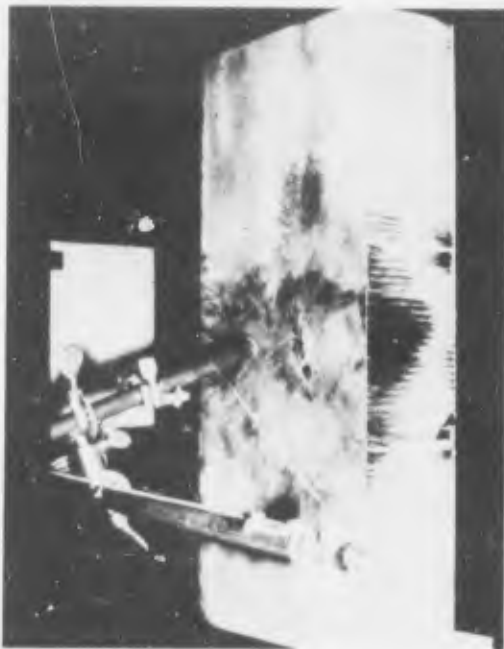
C. Sample BR-108-1 Side 1 After 87 kA Discharge

This panel had a skin thickness of 0.045". This sample received two shots. The first was at 107 kA on side 2. The arc blew a hole into the panel of 0.5" x 0.125" dimension, gave pitting of the surface over an area of about 1.5" x 0.5" and caused delamination of the skin from the honeycomb over an area of about 2" diameter.

The second shot was at 87 kA on side one and caused approximately the same damage as observed on the other side of the 107 kA level. See Figure 109-C.

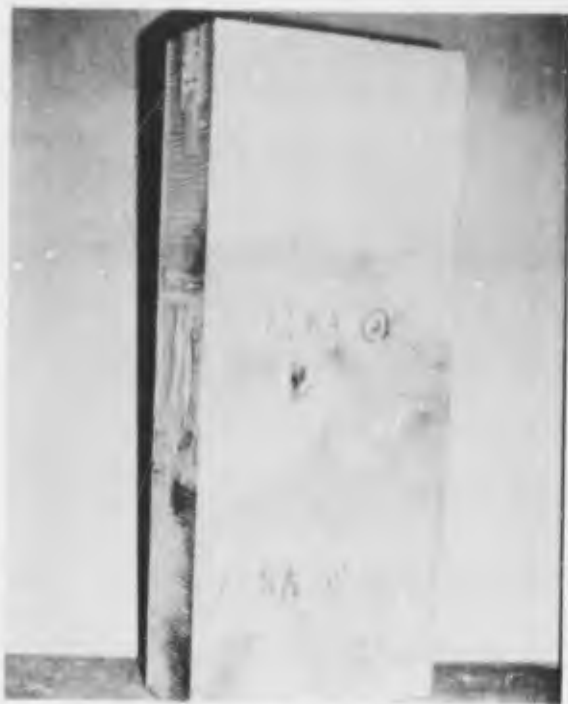
A. Sample BR-108-3
After Tests at
72 kA

In this configuration, there was one test on the panel at a current level of 71.5 kA. At the arc-impingement side, the arc blew one small hole in the center of the panel. On the other side, the arc exited from one corner of the panel. At both points the damage was about the same as was caused by similar current levels with the sample clamped in the ground structure.

After this test with the panel isolated from the ground structure, it was then tested with one edge solidly grounded, like the previous panels that had been tested. The test was made at a level of 71.5 kA on the other face. The shot again caused some puncturing of the panel and discoloration over the surface of the panel. Figure 110-A shows the damaged panel after the above tests.
